**Flood Control Project Maintenance
Levee Inspections****LMA District Cover Sheet****Spring 2013 Levee Inspection Results****Reclamation District No. 2104 Peters Pocket Tract**

Spring 2013 Levee Inspection Results

Reclamation District No. 2104 Peters Pocket Tract

Waterway			Bank	Unit Miles
Unit No. 01 Cache Slough			Left	7.40
	Spring (March - May)	Summer (June - August)	(September - November) Fall	Winter (December - February)
Unit Maintenance Rating (Fall Only)				
Date of Inspection	04/26/2013 - 04/26/2013			
DWR Inspector	Herman Phillips			
Accompanied By

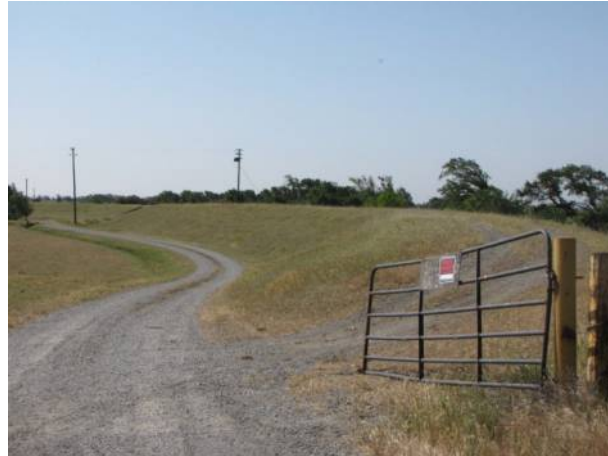
Levee Mile Report Line	4
Start Levee Mile	0.00
End Levee Mile	0.00
Location	Land Side
Category	
Item	Vegetation
RD 2104 Levee mile 0.02 looking downstream from landward slope. Photo taken 4-26-2013.	
phillips_s_20130426_377.JPG

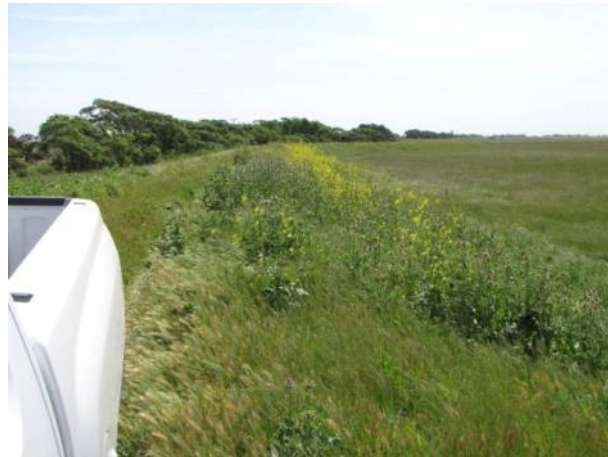
Levee Mile Report Line	24
Start Levee Mile	1.40
End Levee Mile	7.40
Location	Crown
Category	
Item	Crown Surface / Depressions / Rutting
Overgrown crown roadway. Photo taken 5-2-2012.	
phillips_s_20130325_344.jpg

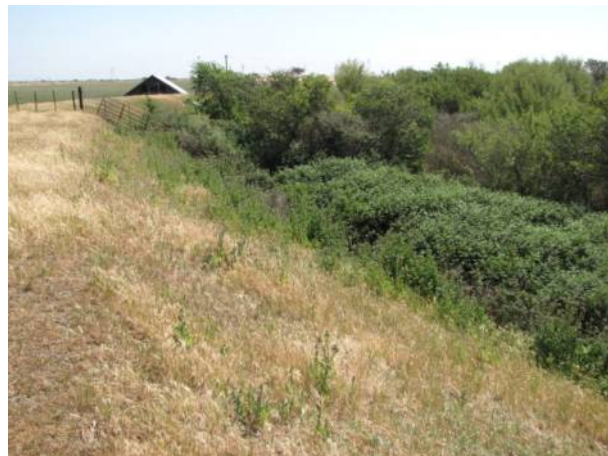
Levee Mile Report Line	27
Start Levee Mile	1.50
End Levee Mile	1.56
Location	Water Side
Category	
Item	Vegetation
RD 2104 levee mile 1.50 looking downstream waterside slope unsatisfactory growth on slope. Photo taken 4-26-2013.	
phillips_s_20130426_379.JPG

Waterway					Bank	Unit Miles	Inspection Start/End		Inspector
Unit No. 01 Cache Slough					Left	7.40	04/26/2013 04/26/2013		Herman Phillips
LMR No.	Levee Mile		Category	Item	Location * + Rating	Action/Comment	GPS Latitude/Longitude		Issue No. Photo
	Start	End					Start	End	
27	1.50	1.56		Vegetation	WS U Ma	V2 : Remove the wild growth other than native grasses from the levee slopes.	38.295706 ° -121.742451 °	38.295454 ° -121.741529 °	49 Y
							DWR ID: DWR_RD2104_01_s_2013_49		
28	1.50	1.52		Vegetation	WS U Ma	V2 : Remove the wild growth other than native grasses from the levee slopes.	38.295712 ° -121.742446 °	38.295726 ° -121.742031 °	48 Y
							DWR ID: DWR_RD2104_01_s_2013_48		
29	1.52	3.14		Vegetation	CR M Ma	V2 : Remove the wild growth other than native grasses from the levee slopes.	38.295738 ° -121.742033 °	38.297566 ° -121.730175 °	32
							DWR ID: DWR_RD2104_01_s_2012_32		
30	1.57	1.60		Vegetation	WS M Ma	V2 : Remove the wild growth other than native grasses from the levee slopes.	38.295263 ° -121.741415 °	38.294915 ° -121.741277 °	22

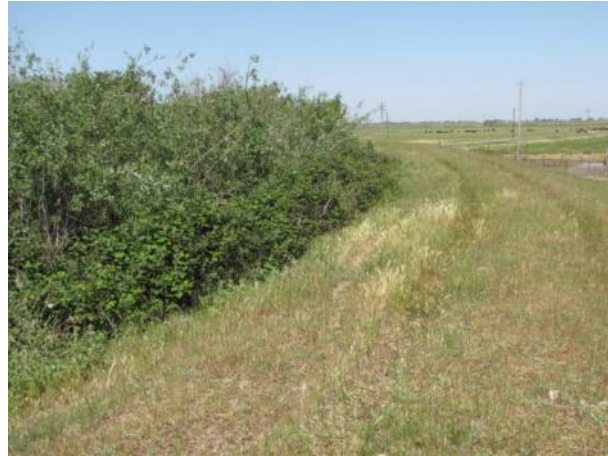
Levee Mile Report Line	28
Start Levee Mile	1.50
End Levee Mile	1.52
Location	Water Side
Category	
Item	Vegetation

Looking back upstream from levee mile 1.52. Unsatisfactory growth has taken over levee section shoulder and slope. The levee can't be seen and is completely blocked. Photo taken 4-26-2013.

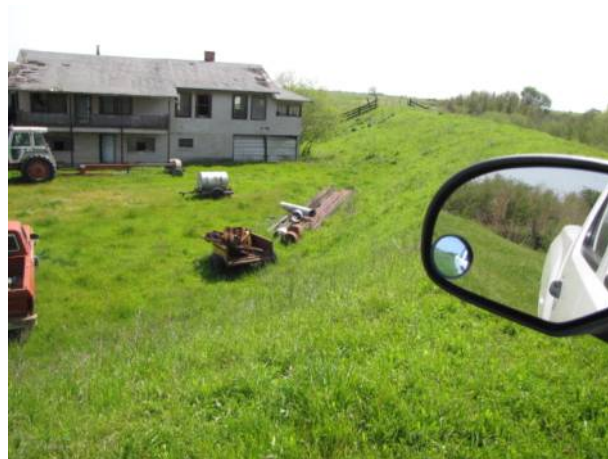
Levee Mile Report Line	31
Start Levee Mile	1.64
End Levee Mile	1.64
Location	Land Side
Category	
Item	Encroachments

DWR ID: DWR_RD2104_01_s_2012_22		
31	1.64	1.64		Encroachments	LS M Ma	MA : Material Inspector Comments: During the spring 2012 inspection, this encroachment hadn't been removed from the levee toe.	38.293747 ° -121.739126 °	38.293747 ° -121.739126 °	23 Y
							DWR ID: DWR_RD2104_01_s_2012_23		
32	1.69	2.60		Vegetation	CR U Ma	V2 : Remove the wild growth other than native grasses from the levee slopes. Inspector Comments: This unit has not improved since the last inspection, nothing has been done. 2012.	38.294125 ° -121.740428 °	38.294290 ° -121.726933 °	15 Y
							DWR ID: DWR_RD2104_01_s_2012_15		
33	2.08	2.09		Erosion / Bank Caving	WS M Ma	E1 : Note and monitor erosion site.	38.292027 ° -121.734575 °	38.291947 ° -121.734453 °	16
							DWR ID: DWR_RD2104_01_s_2012_16		
34	2.32	3.14		Crown Surface / Depressions / Rutting	CR M Ma	C2 : Repair depressions or ruts in the crown or slope.	38.291940 ° -121.730687 °	38.297485 ° -121.730149 °	35

Looking at the material within 10-foot of landward toe levee mile 1.64 RD 2104. Photo taken 4-14-2011

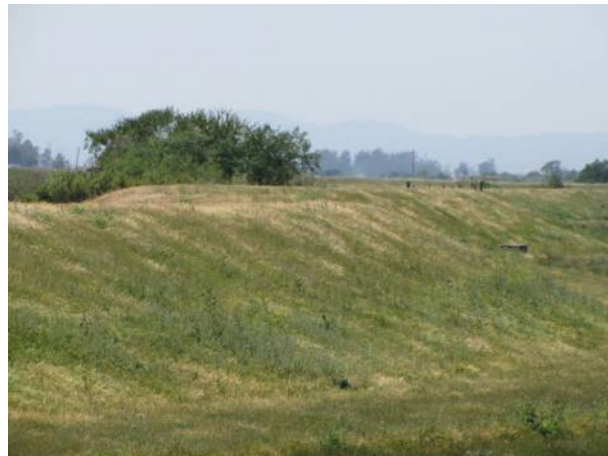
Levee Mile Report Line	32
Start Levee Mile	1.69
End Levee Mile	2.60
Location	Crown
Category	
Item	Vegetation

Looking back upstream from levee 2.60 back to levee mile 1.69. Landward slope and crown roadway is overgrown. Photo taken 4-26-2013.

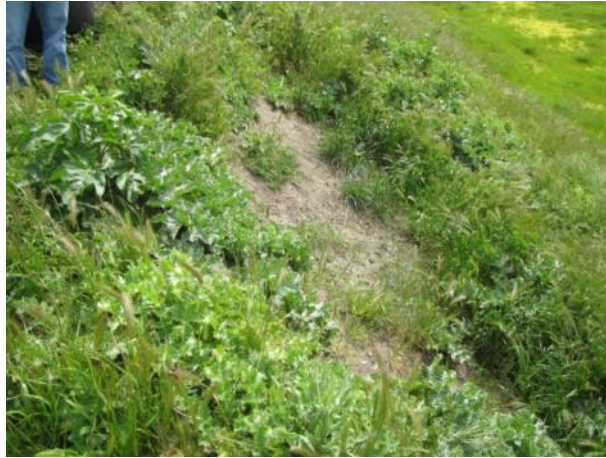
Levee Mile Report Line	42
Start Levee Mile	4.88
End Levee Mile	4.88
Location	Land Side
Category	
Item	Erosion / Bank Caving
Erosion noted at levee mile 4.88 made by livestock along landside slope. Photo taken 4-14-2011.	
phillips_s_20130325_343.jpg
